CONSERVATION FOR PRESENTATION: A KEY FOR PROTECTING MONUMENTS

Roberto Nardi

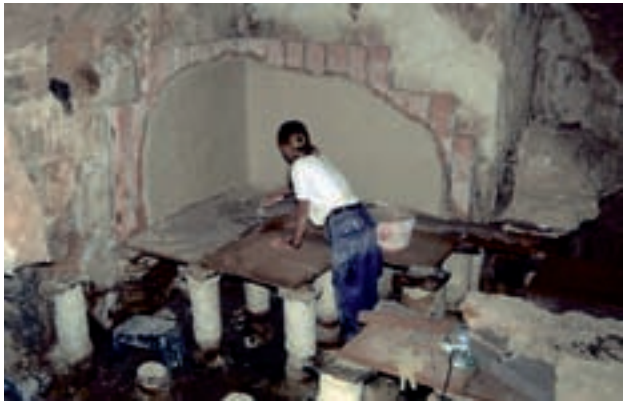
Fig. 1 The Large Baths, Masada, Israel. A model of the suspended floor and of the hot air circulation system on the walls, during restoration in the *caldarium*.

It was therefore decided to integrate a portion of pavement and wall, joining original elements still *in situ* with reproductions of the originals. Twenty-four small pillars were repaired and brought up to their original height by using round terracotta slabs and a mortar of slaked lime and tufa powder in a ratio of 1:2. The restored parts of the pillars were plastered to distinguish them from the original. Over these, 22 terracotta *bipedali* (60 × 60 cm and 5 cm thick) were positioned. The floor area thus created was spread with a double layer of mortar composed of slaked lime, tufa powder and stone powder (1:1:1), as had originally been used as the setting bed for an *opus sectile* pavement. To demonstrate how air circulated in the walls, a section of wall was reconstructed by applying 80 terracotta *tubuli* covered by a double layer of plaster, the original rendering for either wall paintings or stone cladding.

In total, 8 m² of floor were reconstructed and 6 m² of wall. Fig. 1. A cross-section of the structures as they used to be was thus created and visitors and especially guides now have a tool that helps them in reading the monument and understanding how this part of the baths functioned. Today, on entering the Large Baths from Masada's esplanade, where extreme temperatures, dust and wind make every outdoor moment a challenge, the visitor has the opportunity to appreciate the level of wealth and well-being of those who, at the turn of the first century, built Masada's edifices, and to fix — on the basis of material evidence — a small piece of the puzzle of the site.

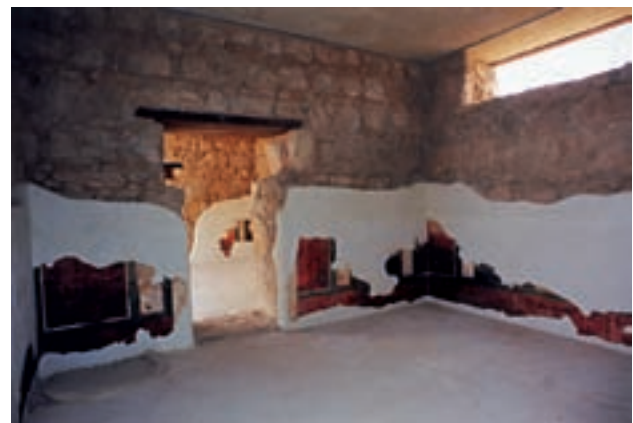
Fig. 2 Liscat Hamefaked, Masada, Israel. One of the rooms after the re-application of the wall paintings.

The canvas and the glue were still in good condition; the *intonachino* was almost completely lost and almost only the colour glued to the canvas was left. Once the panels were accurately documented, a preliminary dry cleaning was implemented. After this, the colour was consolidated by applying a 10% solution of Primal AC33 and a layer of lime mortar was applied in order to obtain a flat, homogeneous surface. A new *velatino* (canvas textile) was applied on this mortar stratum and the canvas applied during the 1960s was removed using water vapour.

A new *velatino* was then applied to the painted surface using a 15% solution of Paraloid B72, and a 10 mm sacrificial layer was applied on the reverse side of the fragments. This layer was made of lime mortar with an extra-light filler (Perlite) added and had a double function: it worked as a bridge between the original colour and the new synthetic support, and at the same time was an easily reversible layer in case this would be required in the future.

After the removal of the *velatino*, the cleaning of the painted surfaces was carried out by using poultices of ammonium carbonate, diaminoethanetetraacetic acid (EDTA) and NeoDesogen, (30 g, 25 g, 10 cc, in 1 L of distilled water) applied with household tissue paper for a period of three minutes. The paintings were finally set on 15 mm aluminium honeycomb support by using Araldite AV5308, applied on the sacrificial layer.

Once back in Masada the panels were replaced in the original position, screwed to metal support on the walls, in a roofed new building placed on the main visitors' route. For this purpose, using the excavation records, the walls were rebuilt sufficiently high to support a roof and the visitor route was redesigned so that the new building was included in the main itinerary, which was followed by more than 500,000 visitors a year, Fig. 2.

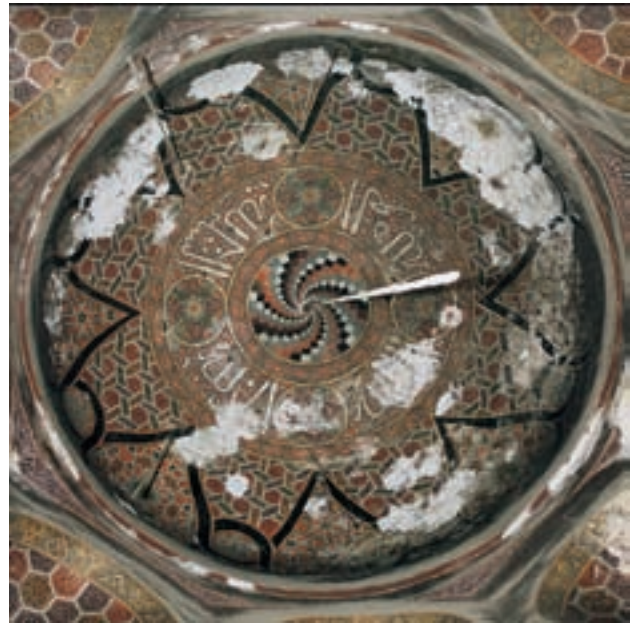
Fig. 3 Madrasa Amiriya, Radà, Yemen. The painted north eastern dome as it appeared in 2000.

All the surfaces were dusted with sable or soft-bristle brushes. Where whitewash thickly covered the paintings it was necessary to remove it mechanically with scalpels. In the areas where there were denser layers of dust, the cleaning was performed with 'Wishab' (now Akapad) sponges. In the areas affected by lamp black deposits and carbonated layers, it was necessary to make repeated applications of a solvent mixture of ethanol, ammonia, acetone (propanone) and water, left to act on the surface through paper tissues for a few minutes.

Where the paint was raised, the flakes of colour were re-adhered to the plaster by impregnating them with acrylic resin diluted in water. Consolidation of detachments between the plaster and the wall support called for the use of a consolidating material based on hydraulic lime, which was injected with syringes. The lacunae in the plaster were stuccoed with a mortar made of lime and gypsum. Pictorial integration of the lacunae was performed entirely with watercolours, distinguishing the areas that could be integrated by reconstructing missing motifs from those that could not be integrated because they were too large.

Lacunae surrounded by well-conserved pictorial features were thus integrated by reconstructing the lost motif, leaving a slight undertone of the colour so that the treated area could be recognized up close. In contrast, the larger lacunae were treated with a background colour that blended with the general tone of the surrounding painting, without reconstructions, creating a uniform plane behind the surviving colours and allowing the forms to emerge. The result of the restoration treatment as a whole was to recover a monument that was virtually lost and return it to daily use by worshipers and the public, Figs 3–5.

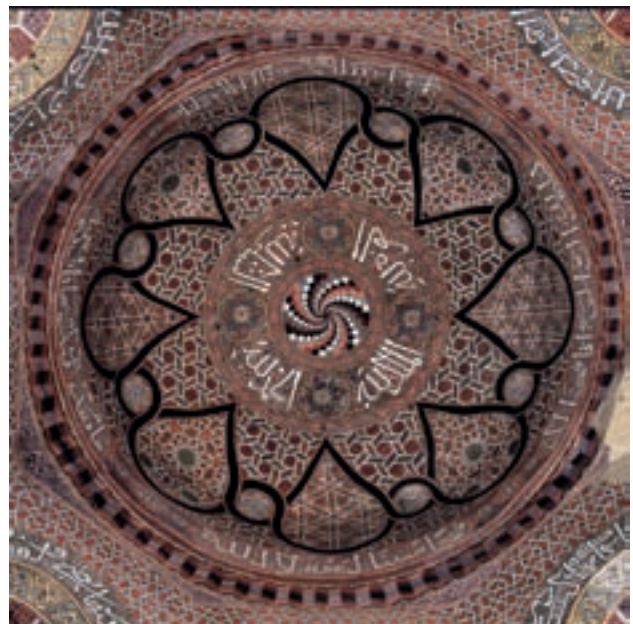
Fig. 4 Madrasa Amiriya, Radà, Yemen. The painted north eastern dome after conservation.

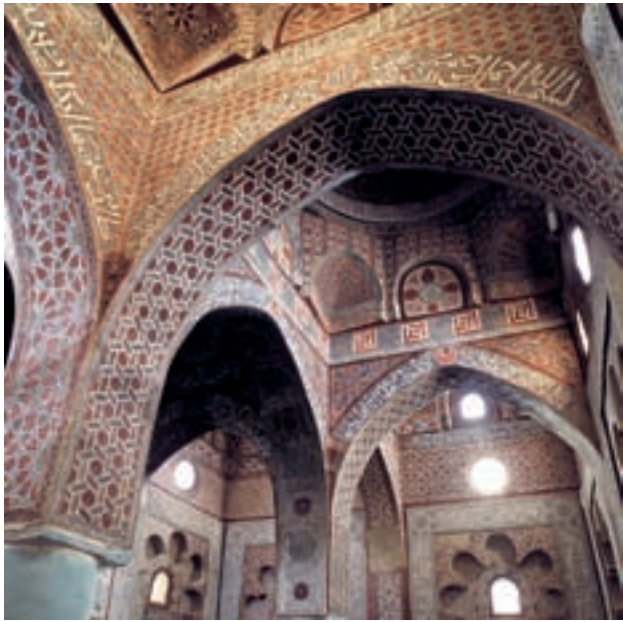
Fig. 5 Madrasa Amiriya, Radà, Yemen. A view of the prayer hall after conservation.

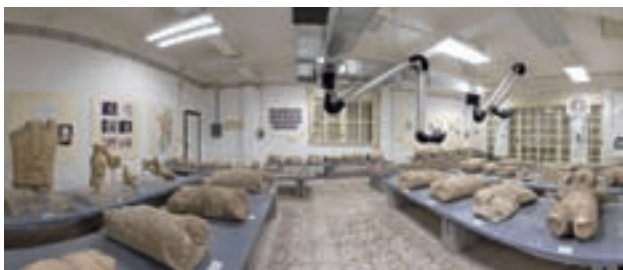
Fig. 6 Monte Prama, Sardinia, Italy. Some of the 5000 fragments of the prehistoric statues.

The programme consists of a ‘new excavation’ among the mountain of cases containing the fragments, with the objective of remounting some of the statues and the goal of understanding this unique phenomenon, which is of fundamental importance in reconstructing the history of the Nuragic peoples, Figs 6–7.

The programme is well under way and will conclude in the autumn of 2008. Currently, documentation of the fragments, cleaning with atomized water and first attempts at matching joints are being undertaken. The worksite is open to the public, and for this purpose a welcoming gallery has been prepared (Fig. 8), a dedicated web page has been posted and activities have begun for schools, citizens and the media. Thanks to the conservation

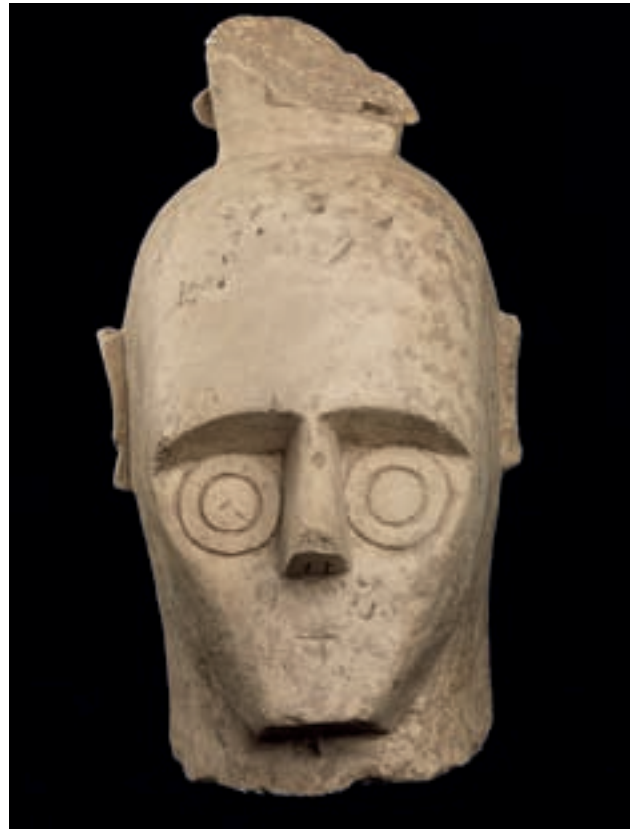
Fig. 7 Monte Prama, Sardinia, Italy. One of the sculptures representing the bust of a boxer.

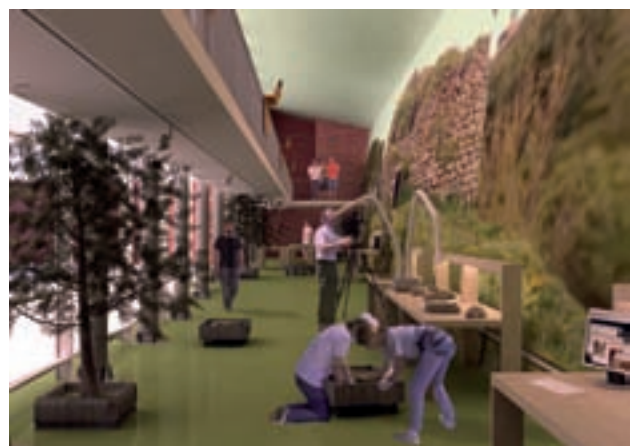
Fig. 8 Monte Prama, Sardinia, Italy. ‘The Gallery’, a laboratory open to the public (rendered image).
