**8ο Συνέδριο
Διεθνούς Έπιτροπής
για τή Συντήρηση τών Ψηφιδωτών (ICCM)**

**WALL AND FLOOR MOSAICS:
CONSERVATION, MAINTENANCE, PRESENTATION**

ANTONIO CASSIO, ROBERTO NARDI, KRISTIAN SCHNEIDER

ZEUGMA MOSAICS RESTORATION PROJECT

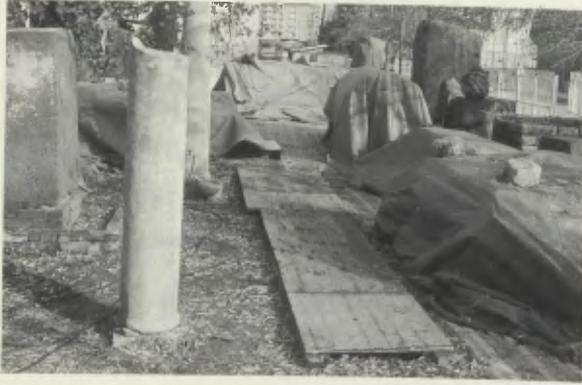
The material outside in the museum garden had been covered best as possible with some heavy plastic sheeting, but not protected from frost, moisture from the ground, and - due to the resulting damp conditions under the plastic covering - from microbiological attack (fig. 1). The fragments were transported to the main laboratory and spread on the ground. A first recognition was carried out trying to establish the identity, the number of fragments and the extension of the single mosaics. Once identified they were divided by single pavement and stored in the re-organized storage room.

It became immediately clear that one year storage in open-air conditions had taken its toll on the already compromised conservation conditions of the mosaics. Numerous microbiological attacks had occurred on the materials used to detach the mosaics - glues, canvas covering, and timber panels - making them fragile or weak. In addition the extreme temperature conditions (-5 to +45 °C) had hardened the polyvinyl glues employed resulting in the loss of tesserae, detachment of entire sections of mosaic still in place from the canvas, etc.

1. Mosaics stored in the Gaziantep Museum garden.

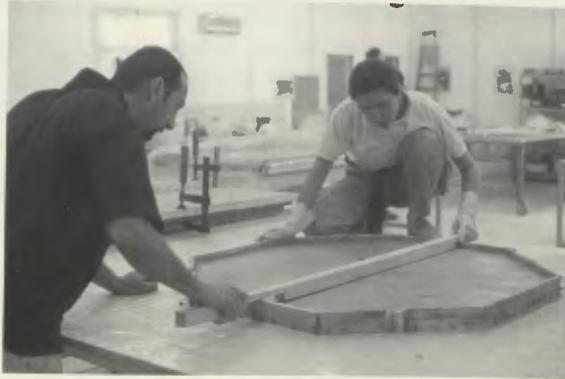
The application of the mortar is carried out with the utmost care to compress and thoroughly work the material with spatula and trowels in order to obtain a very compact layer, neatly applied to the lightweight panel and absent of voids or air bubbles (fig. 2).

2. Application of mortar on a lightweight panel.

- *Application of the fragments from the front on lime-based mortar:* the thus prepared panels are ready for application. Following the planning of the succession of the single panels to apply the application starts with the central panel of the mosaic positioned according to its collocation in the mosaic on a timber working table stretched over the floor. Being in direct contact with the floor limits the vibrations during the beating and other work phases. The lightweight panel is framed with stripes of wood and metal fixed to the underlying timber panel layer. The framing stripes are of the same height for the complete mosaic, based on the height of the lightweight panel, the depth of the tesserae and of the mortar necessary. The depth varies from mosaic to mosaic from a minimum of 2,5 to a maximum of 5 cm. At this point the mortar is applied. It is a hydraulic mortar made of the following components:

Parts	Component	Notes
1	Marble powder	Not sieved
1	Volcanic earth (pozzolana)	Not sieved
1	Brick powder	Not sieved
0,5	Hydraulic lime (Lafarge)	-
1	Lime putty	-
3%	Acrylic emulsion (Primal AC33)	Pure

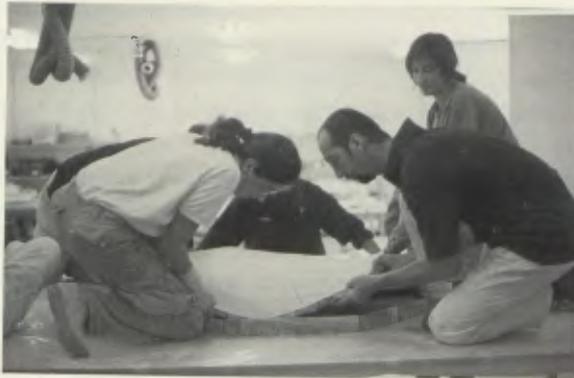
- Mounting of the fragments on the panels: the fragments, placed face down, are slightly wetted and then covered with the "buiacca", a liquid mortar with the function to penetrate the spaces in between the tesserae and to function as a connection between the tessellatum and the new setting bed (fig 3).

The thus prepared fragment is positioned on a compressed wood fibre panel, turned front side up and then posed on the new setting bed. At this point the fragment is pushed into the lime-based mortar with the help of modified, heavy finishing trowels. This operation is repeated until the tessellatum is perfectly aligned with the elements in timber and iron making up the frame prepared for the mounting.

3. The mosaic fragment is set on the fresh mortar.

Parts	Component	Notes
1	Marble powder	Not sieved
1	Volcanic earth (pozzolana)	Not sieved
1	Brick powder	Not sieved
0,5	Hydraulic lime (Lafarge)	-
1	Lime putty	-
6%	Acrylic emulsion (Primal AC33)	Pure

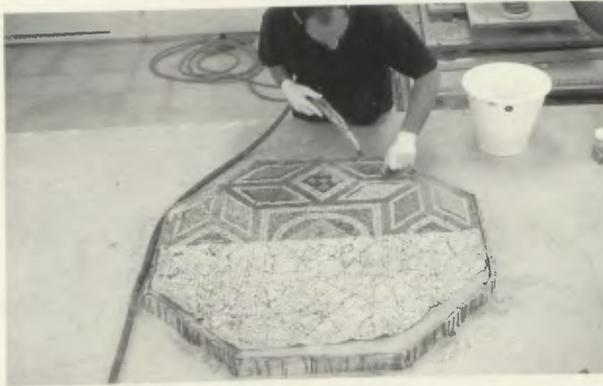
- *Removal of the canvas/cotton gauze covering*: the removal of the canvas applied for the detachment and of the cotton gauze applied after the integration on clay is executed by the creation of a humid chamber obtained through hot water vapour pushed under a polyethylene sheet put on top of the fragment. After about one hour the hot vapour has dissolved the glue to a point, where a gentle removal of the covering is possible; this is followed by a patient, mechanical operation of removing the remains of glue on the mosaic surface (fig. 4).

4. The canvas covering is removed.

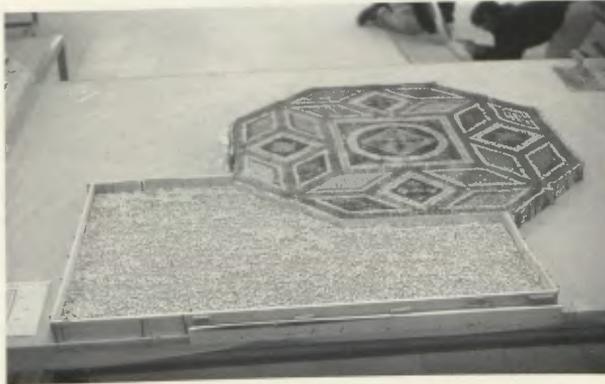
Once the mounting of the first fragment is complete, the process proceeds with the successive ones, mounting about two or three fragments a day. After mounting the last fragment the mosaic is left untouched for about a month giving the mortar the time to set up and harden (figs. 5 - 6).

5. The second panel is fit to the first one.

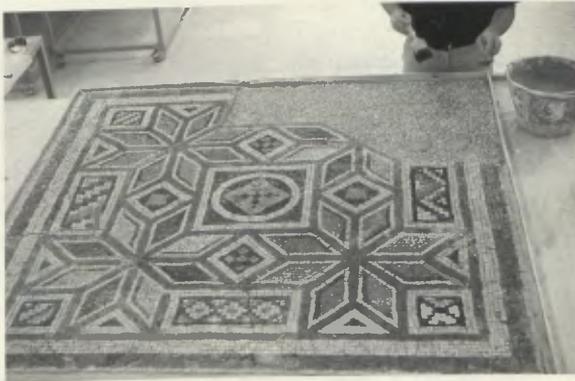
6. The final panel is being prepared with buiacca.
