**8ο Συνέδριο
Διεθνούς Έπιτροπής
για τή Συντήρηση τών Ψηφιδωτών (ICCM)**

**WALL AND FLOOR MOSAICS:
CONSERVATION, MAINTENANCE, PRESENTATION**

ROBERTO NARDI *

THE CONSERVATION OF ZEUGMA

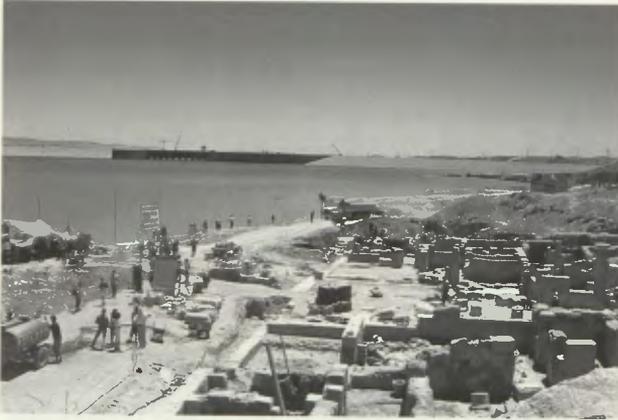
fig.1

During the same period, Zeugma was affected by a major regional hydroelectric project, which involved the construction of various dams. One of these, the Birecik dam and its reservoir, would submerge 30% of the surface of the ancient city during the summer of 2000. The flooding was scheduled to take place in two phases, the first (June 2000) would submerge the so-called "Area A"; the second (end of October 2000) would submerge the so-called "Area B" (fig. 1).

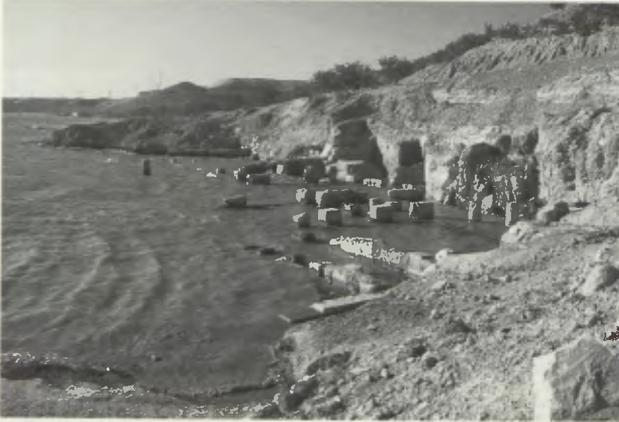
fig.2

- the structures still *in situ*, the trenches and the stratigraphy that had not been disturbed during excavation and detachment operations were sent underwater without any protection (fig. 2).

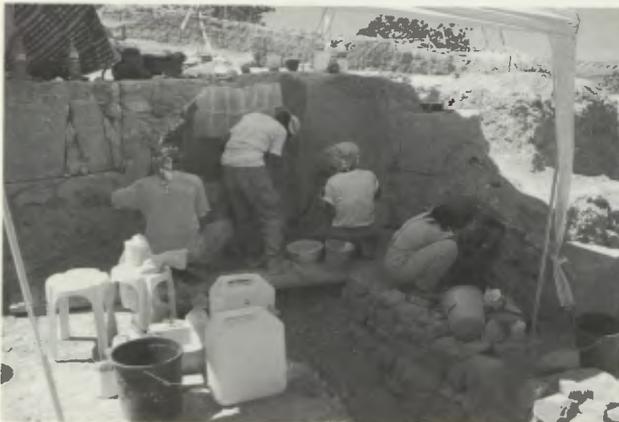
fig.3

To mitigate this phenomenon, the work areas were shaded, and if a mosaic was discovered, instructions were to leave a 10 cm layer of dirt over its surface. This layer was subsequently removed by the conservators during cleaning, which was performed with soft plastic brushes, synthetic sponges, a 2% solution of NeoDesogen in water and a vacuum for liquids. The cleaning was always done by groups of 6-8 people in order to reduce the time of exposure of the surfaces to heat and air and avoid the formation of insoluble layers on the mosaic surfaces (fig. 3).

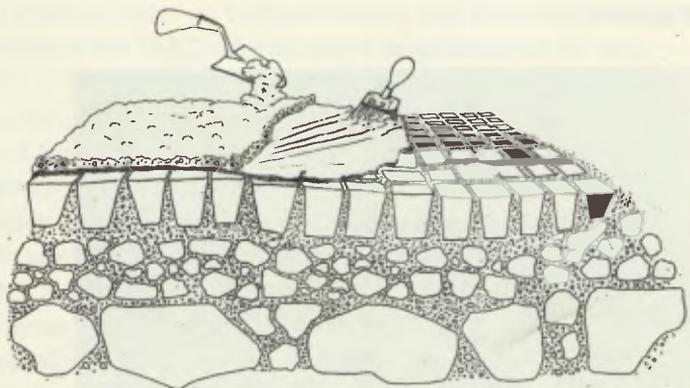
fig.4

When this coat had dried, the protective layer was put on – a 5 cm thick layer of hydraulic mortar composed of Lafarge hydraulic lime, slaked lime, brick powder and stone dust in a ratio of 0.5, 0.5, 1.5, 0.5. This layer was extensively worked to obtain perfect adhesion to the surface beneath it and improve the carbonation process of the aerial components of the mixture. This new surface will protect the original from the mechanical action of the water and act as a sacrificial layer. At the same time, its hydraulic character will enable it to continue to set in contact with moisture and there will be a progressive improvement in its mechanical resistance. In this way, every exchange with the environment will occur on the applied layer and not directly on the original (fig. 4).

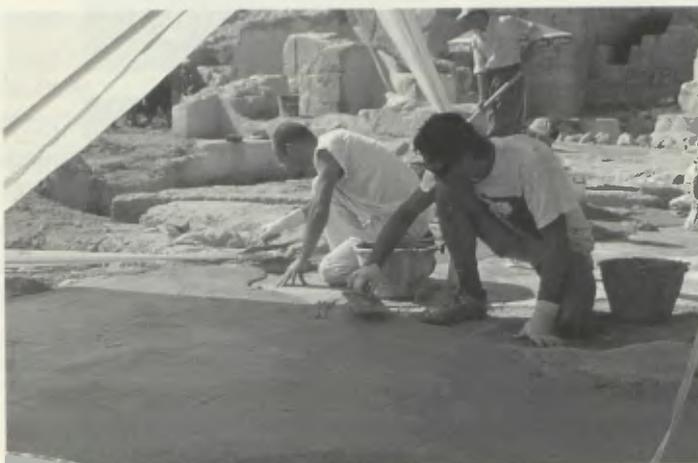
fig.5

The choice of hydraulic mortar was dictated by its high resistance, its mechanical and hydraulic qualities, its durability and complete compatibility with the original surfaces (fig. 5).

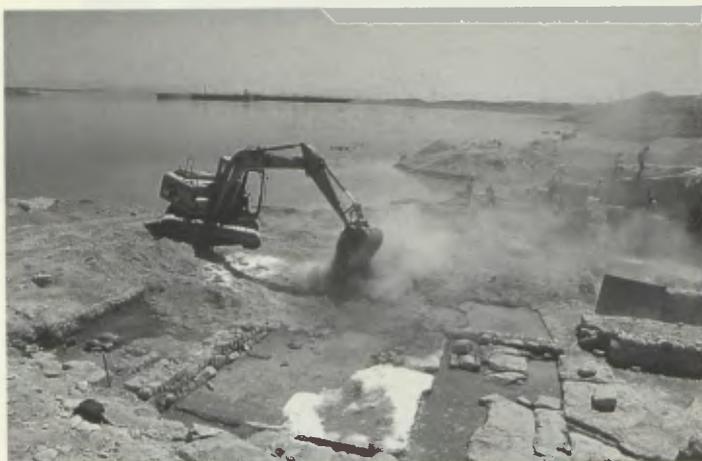
fig.6

All the trenches and structures were reburied with a double layer of materials: the first was composed of soil and sand and was about 50 cm thick; the second was also 50 cm thick on average and composed of river pebbles and stones.

The soil and sand applied in direct contact with the structures were dampened and packed to prevent shrinkage during the inundation. Particular care was taken in filling cisterns, covered rooms and irregularities in the terrain to prevent collapses that could damage pavements and building floors. These operations were done by hand, with wheelbarrows and shovels. Mechanical means were used as much as possible for the other reburial work. Generally, all the trenches were filled with a first layer of soil and sand about 50 cm thick, followed by a variable layer of pebbles and stones depending on the slope of the trench. A total area of 8700 m² was reburied, covering 19 excavation areas. The volume of materials used for reburial was 10,500 m³, equivalent to 630 truckloads of sand, pebbles and stone (fig. 6).
