MONASTERY OF SAINT CATHERINE, SINAI

THE CONSERVATION OF THE
**MOSAIC OF THE
TRANSFIGURATION**

Roberto Nardi - Chiara Zizola

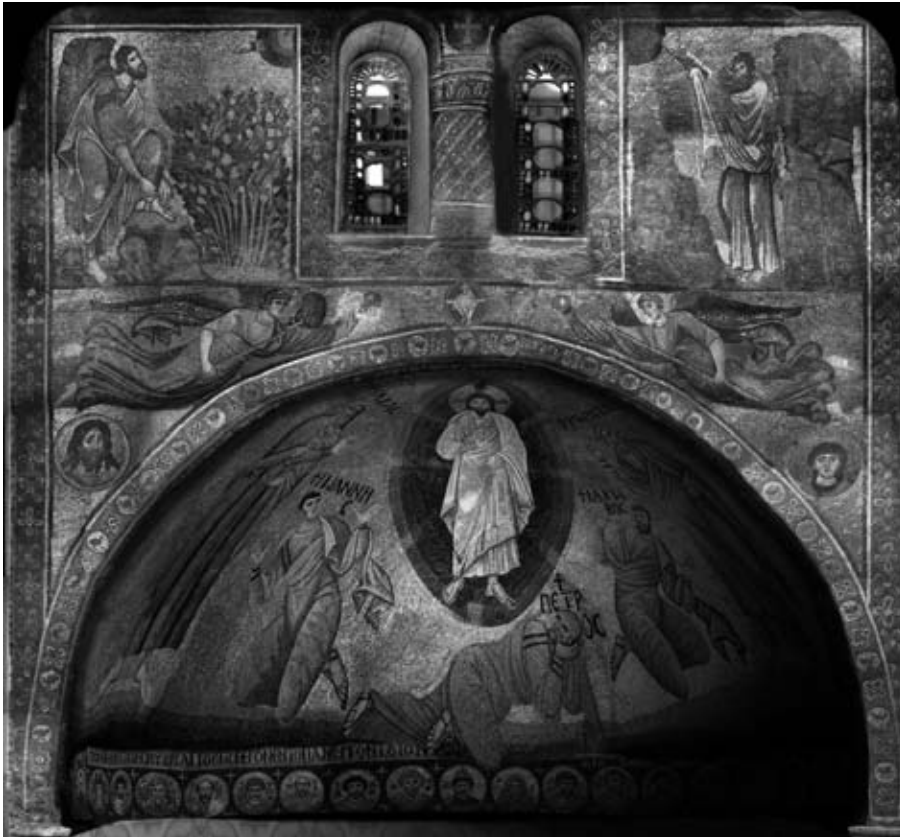
8. The mosaic of the Transfiguration with the apse and the arch.

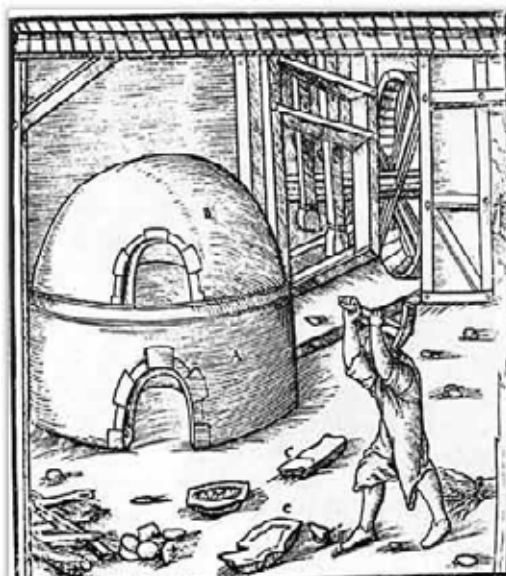
10. Furnace used to produce glass in a sixteenth century representation. (Agricola 1556).

The fusion of the mix took place in two stages, inside wood-fired furnaces. The first phase occurred at about 800°C, obtaining a glassy mass called the "frit." When cooled, it was then broken up and put back into the furnace in special containers of refractory clay - crucibles - for the complete fusion.

The fusion process, at temperatures of 1000-1200°C, took place over the course of a few days. The finely ground coloring substances were then added to the molten mass, which was subsequently allowed to cool down to 900°C. The paste obtained was pressed between two marble surfaces in order to produce glass slabs measuring from one to two centimeters in thickness, generally rounded, called plates. Placed in the cooling compartment of the furnace, the plates were gradually brought to room temperature and became solid.

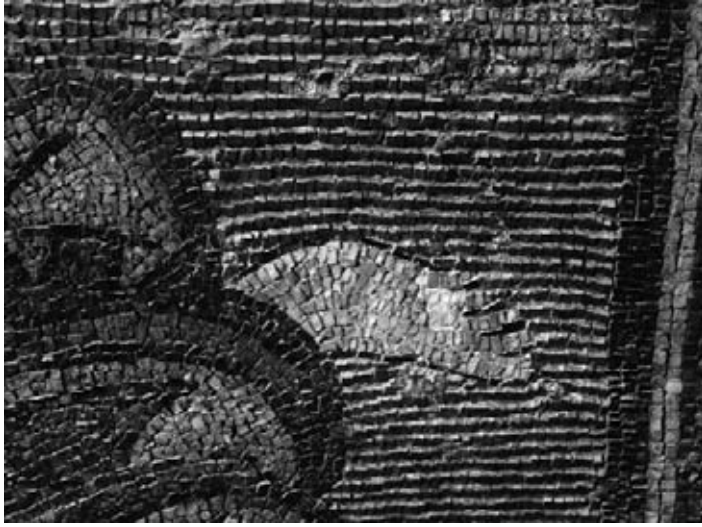
11. The gold and silver leaf tesserae are inserted at an inclination of forty-five degrees.

The inclination of the tesserae and the way they are set are stylistic characteristics that are very significant in this particular form of artistic production. Light and its refraction are key elements in the formal language of a Byzantine mosaic, where it is employed to give the material a wide variety of desired optical effects. Working with the natural light available, the mosaicists knew how to use the gold and silver leaf tesserae to act as mirrors to refract and amplify the light. In the triumphal arch, for instance, which is close to the central and side windows, the tesserae are inserted at an inclination of forty-five degrees, in regular distanced rows. In this way, the natural light was deflected downward, toward the observer.

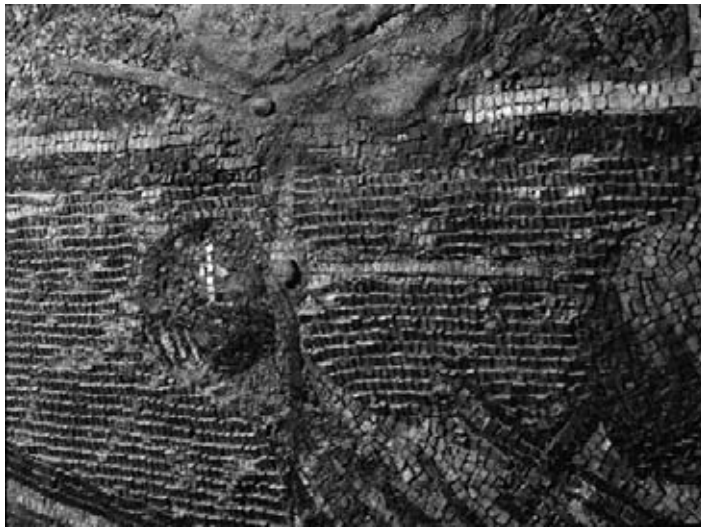
13. Iron rods inserted by monk Samuel in 1847.

At that time, the mosaic already had serious detachment problems in the entire central area, especially at the areas of the semicircular apse comprising the upper part of the figure of Christ, and on the triumphal arch, near the two windows. The entire area coincides with the area that is currently in a critical state. To consolidate the areas close to collapse, the monk used a technique practiced as early as the seventeenth century for the consolidation of wall paintings, inserting iron rods about twenty centimeters long through the thickness of the plaster to support the detached areas.

The consolidation was effected by injecting plaster inside the detached areas through holes made by extracting a tile and drilling into the plaster with a hand drill. In the area depicting Christ, fifty-six holes were drilled; in seven of these, small copper pins were inserted into the plaster, and they were then secured to the underlying granite wall and bedded in a mixture of plaster and casein. At the completion of the treatment, the tiles that had been removed were put back and the metal rods applied by the monk Samuel were removed.

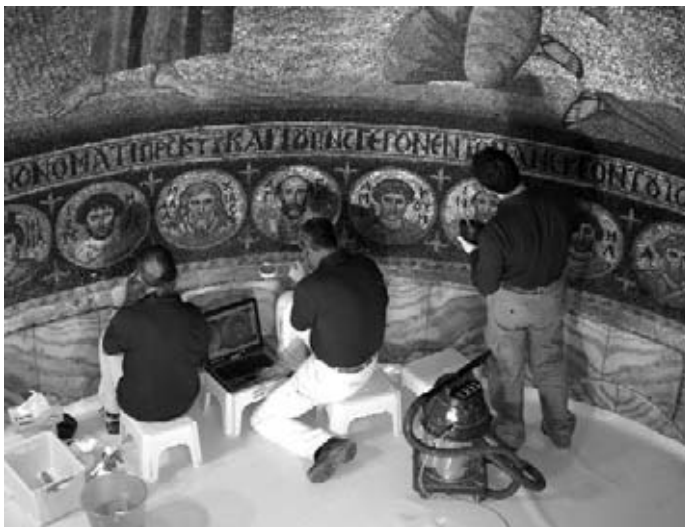
14. General view of the conservators at work on the mosaic of the apse.
